HOME REPORT

22 Dunbar Drive
Muirhouse
Motherwell
ML1 2EN

Energy Performance Certificate (EPC)

Dwelling type: Detached house
Date of assessment: 04 October 2018
Date of certificate: 08 October 2018
Total floor area: 114 m²
Primary Energy Indicator: 172 kWh/m²/year

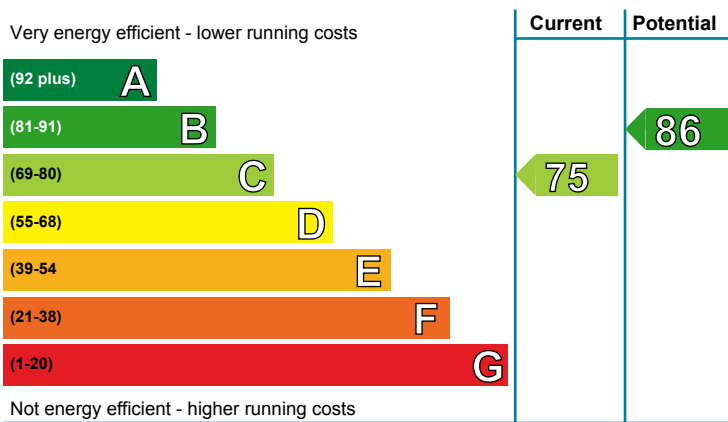
Energy Efficiency Rating

This graph shows the current efficiency of your home, taking into account both energy efficiency and fuel costs. The higher this rating, the lower your fuel bills are likely to be.

Your current rating is **band C (75)**. The average rating for EPCs in Scotland is **band D (61)**.

The potential rating shows the effect of undertaking all of the improvement measures listed within your recommendations report.
